TOGGLE SHEAR TESTING

Test Report

Transverse shear tests with Mateen dowels

Product: Mateen dowels as 38 mm toggle

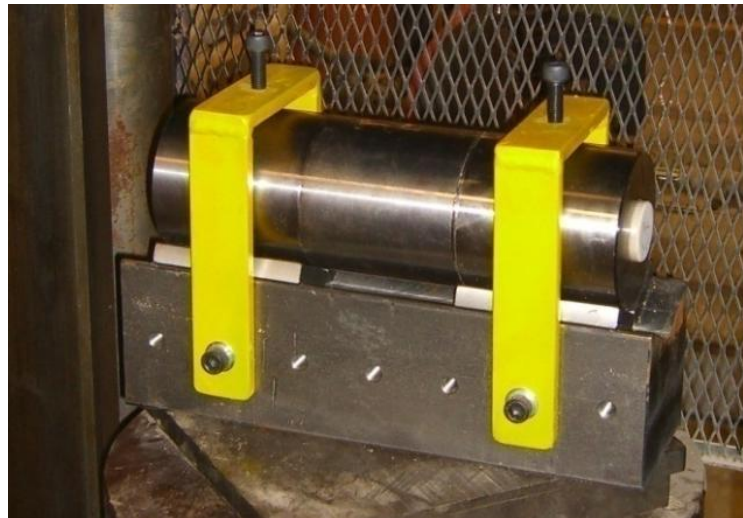
Figure 1: Test setup

The test jig and 8 samples were delivered on 19/04/2010 and stored at a dry place and at room temperature until testing. The test jig included 4 tubes of steel. Two of the tubes were always used for the outer ones, whereas the other two tubes were used for the inner one, which was changed between each test. The outer tubes were supported, whereas the inner tube was free in moving vertically, as shown in Figure 1.

Prior to the testing, the samples were numbered and the diameter was measured. The samples were inserted in the provided test jig. No gap was visible between the inner and outer tubes. The load was applied with a flat plate from the top to the inner tube at a nearly constant rate. The load was recorded in a frequency of 2 Hz. All eight tests were carried out in an AVERY 1000 kN tension/compression test machine at 21 °C by Dr. Steffen Franke and Mark Byrami on the 21st and 22nd of April 2010.

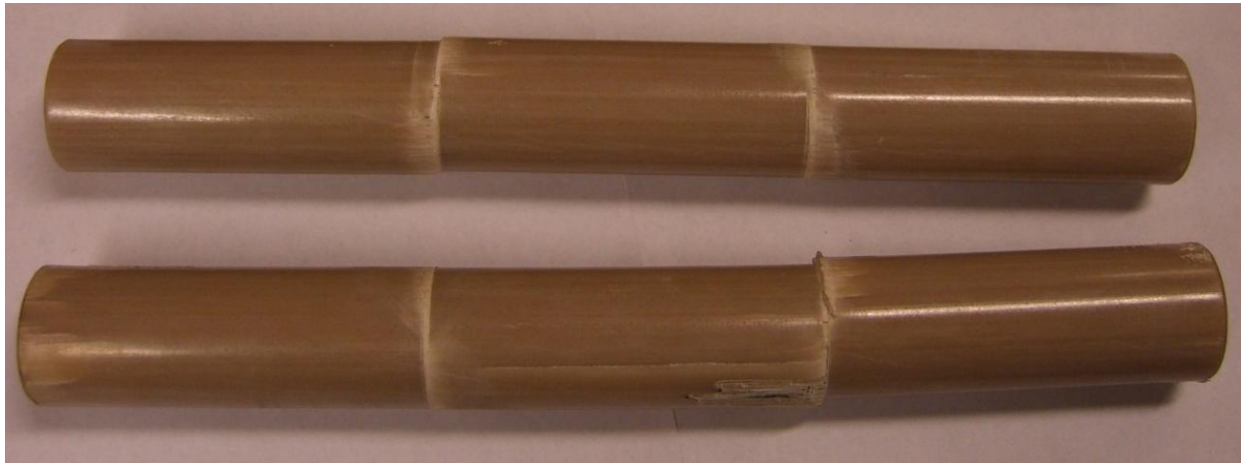
Figure 2: Initial Failure after short displacements

The test results are listed in Table 1. All specimens failed in shear as shown in Figure 2. Upon further displacement of the test machine, the specimen failed in a secondary mode of failure as shown in Figure 3.

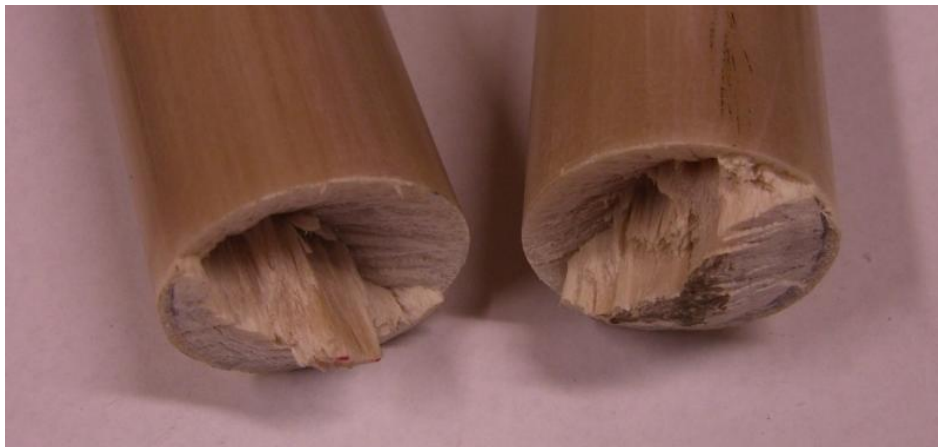
Figure 3: Secondary failure after large displacements
